In-Place Pipe Lining of Pre-action Fire Suppression System at Fort McPherson, GA

Final report

Prepared for Directorate of Public Works
Fort McPherson, GA 30330-1075

Abstract: A pre-action fire suppression system was installed in a portion of the U.S. Army Reserve Component Headquarters at Fort McPherson, GA, when the structure was constructed in 1995. This system, which is normally kept at a standard internal air pressure using air compressors in the basement electrical-mechanical room, is designed to remain dry, and have water in it only in the event of a fire. The Pre-action Fire Suppression System has developed pinhole leaks due to what appears to be galvanic corrosion. The U.S. Army Corps of Engineers Engineer Research and Development Center, Construction Engineering Research Laboratory proposed installing an in-place epoxy lining of the system using a process developed by American Pipe Lining, Inc. The in-place epoxy lining was installed in the pre-action system and the effectiveness of the coating process documented. The work included restoration and lining of all interior pre-action piping mains, risers, branch laterals, and service piping to individual sprinkler head loc

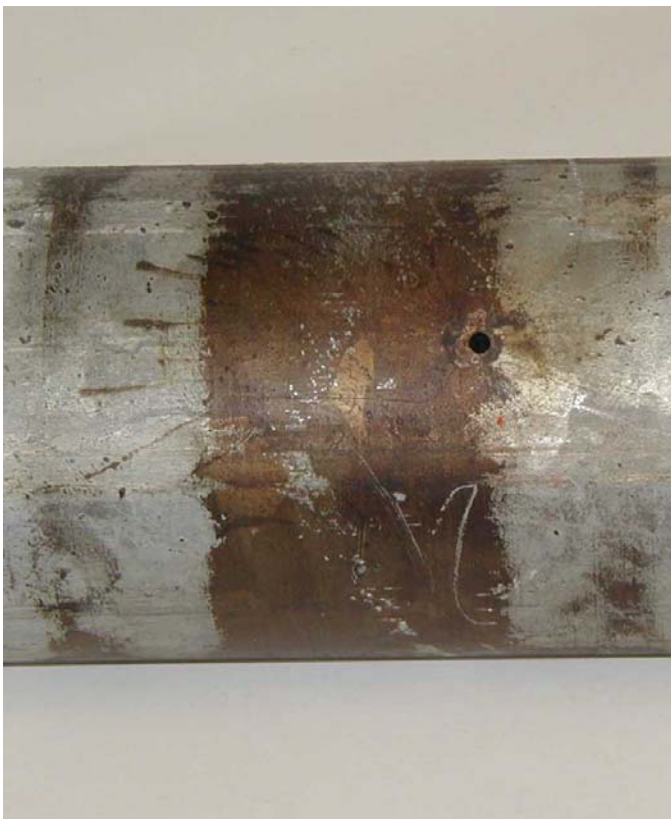
Figure 3. Largest pinhole shown in Figure 2.

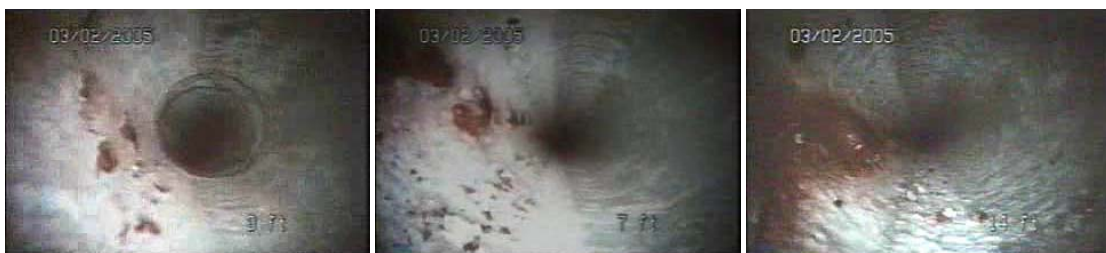
Figure 9. Pipe interior before treatment.

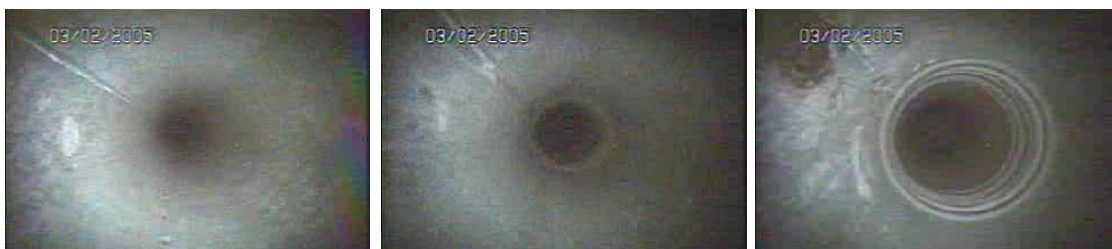
Figure 10. Pipe interior following grit blast.

When the pipe segment was completely dried, a light-abrading agent was distributed in sequenced “pulses” throughout the pipe system to remove any corrosion buildup along the pipe's interior wall. The garnet sand used was a nontoxic, State-approved abrading material. This served to further dry the pipe surface and create a suitable pipe wall anchor tooth to maximize subsequent epoxy adhesion. The prepared surface had a near white-metal blast appearance (conforming to Society for Protective Coatings [SSPC] SP10 Standards), and an anchor tooth (not peened) surface profile of 50 to 75 micrometers (2 to 3 mils) which is measured at the pipe inlet and outlet with profile tape and a dial or probe micrometer. The sand was collected by the portable vacuum system.

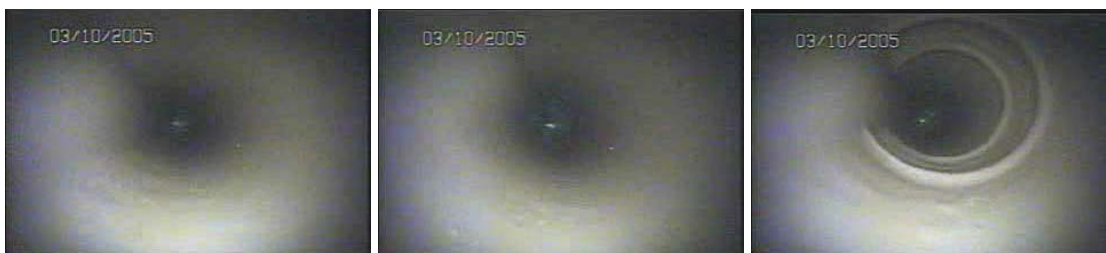
Figure 11. Interior of pipe following epoxy lining.

Once the pipe had reached the proper temperature by blowing hot air through the line at 50 pounds per square inch (psi), the two-part epoxy coating was measured and mixed. The mixed coating was poured into polyvinyl chloride (PVC) pipe “dummies” prepared with quick disconnects on each end. The bottom of the dummy was sealed using thin polyethylene sheet material and the dummy connected between the sprinkler head pipe and the incoming air hose. Once the dummies were connected, the hot air at 50 psi was shot through the line. The high pressure air broke the polyethylene seal and forced the epoxy through the pipe toward the exhaust in a plug, lining the pipe. A second coat was applied after allowing the first coat to cure approximately 8 hours.
